# BRAKING NEWS!

December 2010 • Issue # 23

## Corvette Brake Caliper Reconditioning

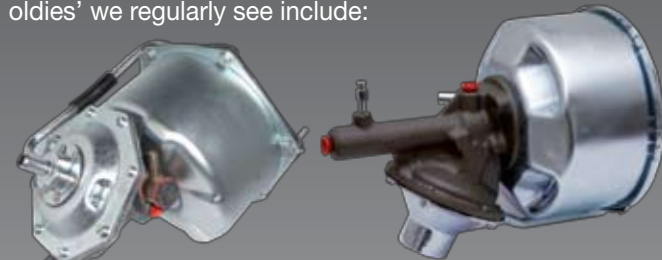
LOCKHEED 6 7/8"  
HYDROVAC FITTED  
TO JAGUARS

ATE HYDROVACS  
FITTED TO BMWs

PBR VH24 BOOSTERS  
ARE A SPECIALTY

GIRLING POWERSTOP  
BOOSTERS ARE FITTED TO  
MANY EARLY ENGLISH  
& AUST MODELS

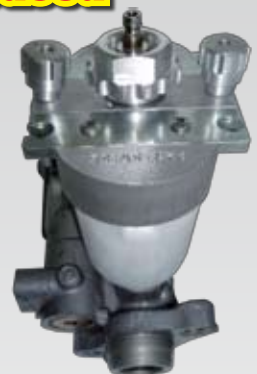
After months of development, we have finally released our pressure bleeder adaptor to suit the PBR oval reservoirs found on many Falcons, Commodores and Magnas.

In an Australian first, we have designed an adaptor that is fast and easy to use, and above all it does not leak!

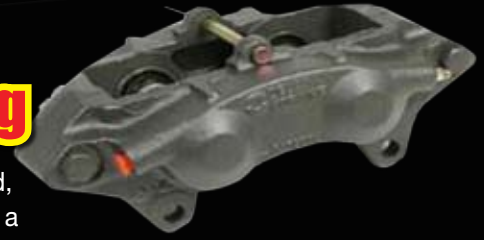
Something we do come across from time to time are very cheap, supposedly resleeved, new brake calipers for Corvettes. These vehicles run a 4 piston 1 7/8" front caliper and a 4 piston 1 3/8" rear caliper. These imported calipers are often resleeved in mild steel and are done in a process where the sleeves are clearance fitted, resulting in piston to bore clearance above factory specifications. To remove the old sleeves and make a custom sleeve to repair is very expensive. This makes paying that little bit extra to get it done right seem not a bad option after all! We also carry caliper kits and pistons for these calipers - see the details on the right.

1 7/8" Front Caliper kit	<b>PW1097</b>
1 3/8" Rear Caliper kit	<b>PW1098</b>
Front Caliper Piston	<b>PW16014</b>
Rear Caliper Piston	<b>PW16015</b>
